Foundations

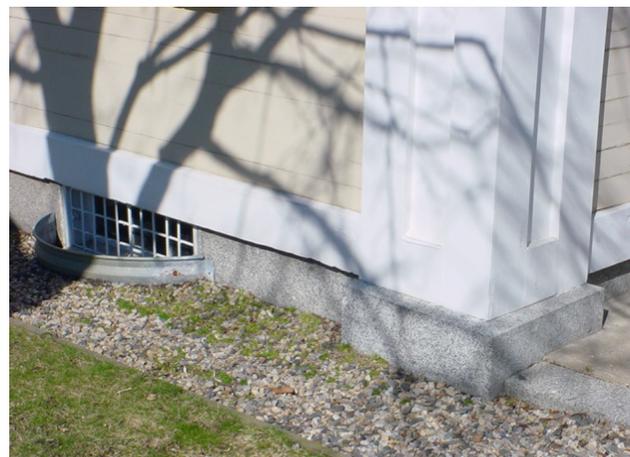
Decorative corner block and window well

Granite foundations are of slab or block construction, with interior pier walls, and occasionally incorporate decorative corner blocks and water tables. Water tables, or water table boards, are decorative features that divert rainwater away from the surface of a building, and most in the District are constructed of wood. Raised foundations often incorporate basement windows, wells, or grilles to allow light into the basement or crawlspace, and to provide ventilation.

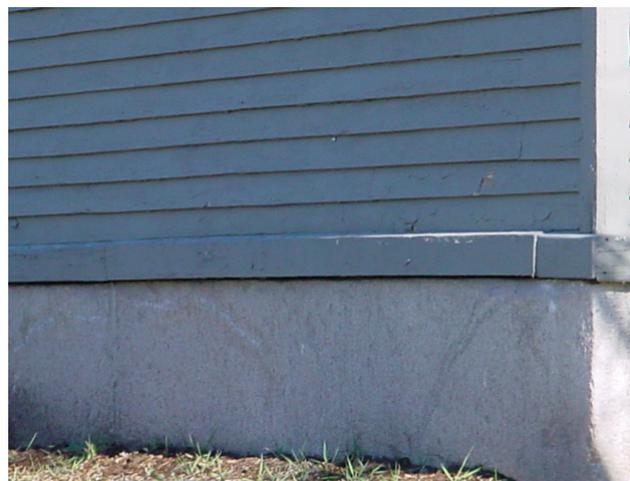
Granite foundation and water table
